Mapping geomorphological hazards in relation to geotourism and hiking trails

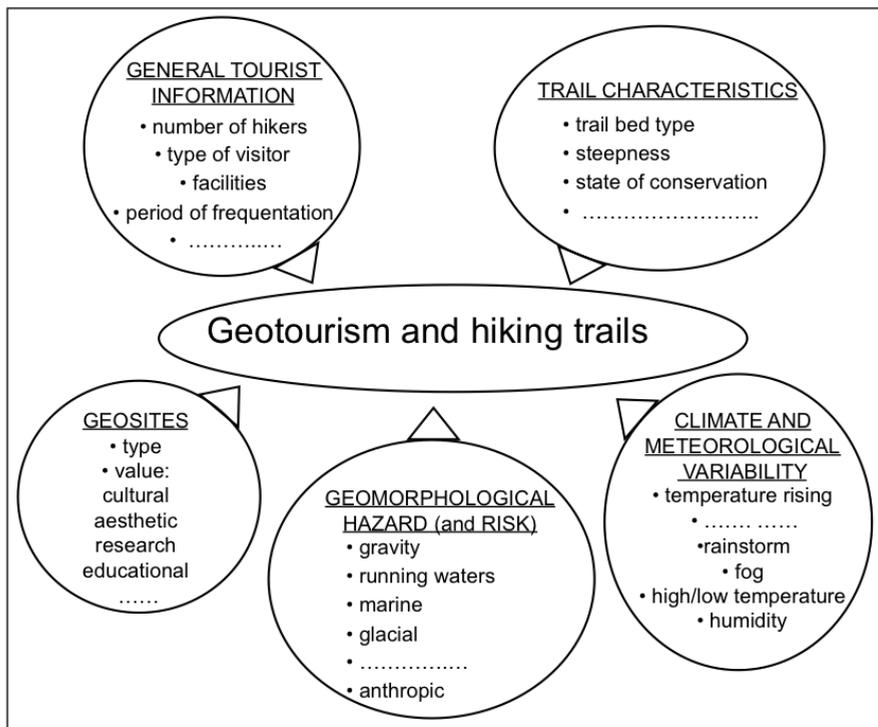
Fig. 1 Main topics to be considered in geotourist promotion, planning and management of hiking trails.

Some main topics were considered with the aim of realising specific thematic maps (geotourist maps), which should be readable by a large number of users and not only by specialists. The maps will include general tourist information (number of hikers, type of visitors, facilities, period of frequentation, etc.); geosites (type, value, cultural, aesthetic, research, educational, etc.); trail characteristics (trail bed type, steepness,

state of conservation, etc.); geomorphological hazard and risk (running water, marine, glacial, anthropogenic hazards, etc.); climate and meteorological variability (rainstorm, fog, high/low temperature, humidity etc.) (Fig. 1).

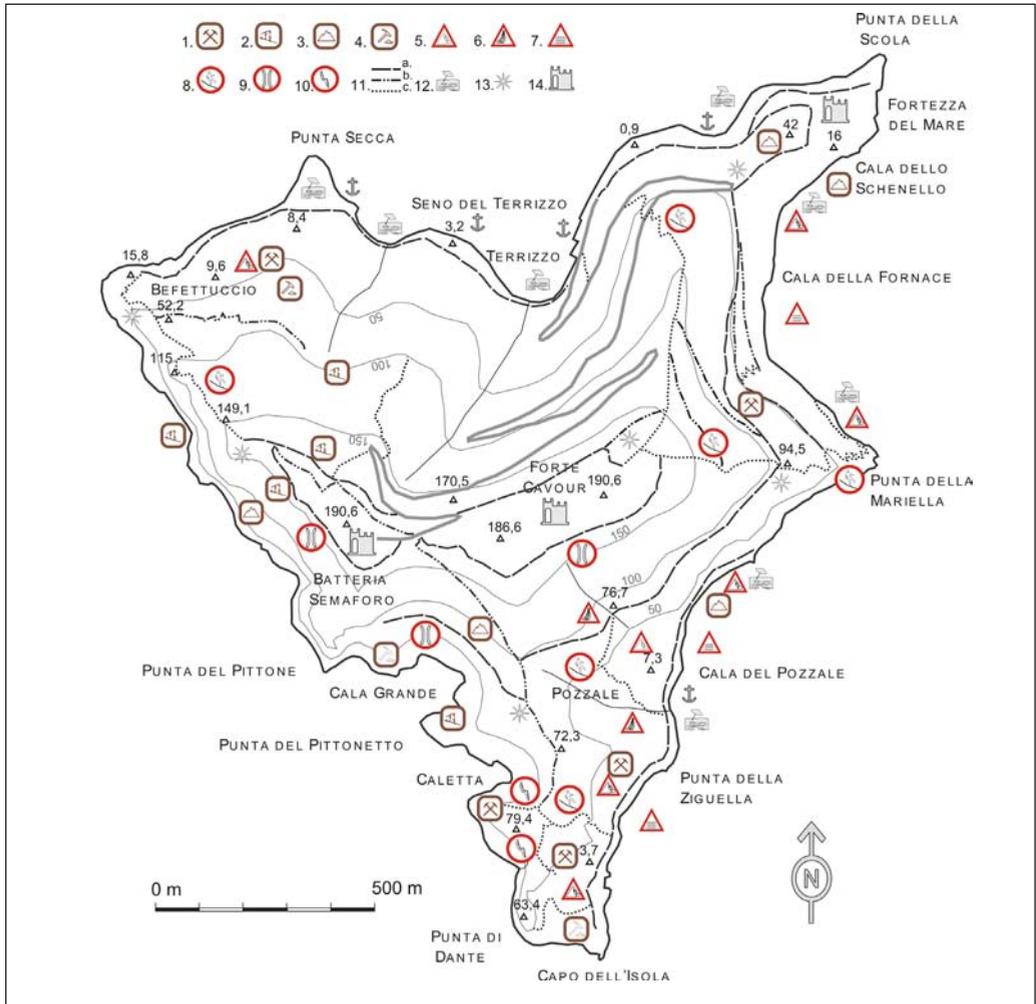
Types of geosites	Tourist vulnerability (hiking path features)
1. Geomine	8. Slippery or rambling track
2. Karst	9. Narrow trail
3. Geomorphological	10. Exposed path
4. Geological	11. Track steepness – a. low; b. medium; c. high
Geomorphological hazards	Other geotourist emergences
5. Rock fall	12. Beach
6. Debris flow (associated with heavy rainfall)	13. Geo-panoramic point
7. Sea storm	14. Military structures

Fig. 3 Geotourist map of Palmaria Island and legend (after Brandolini et al., 2009).

The geotourist map (Fig. 3) shows the location of the main geosites, geo-panoramic points, and historical sites related to hiking trail features and presence of geomorphological hazards.

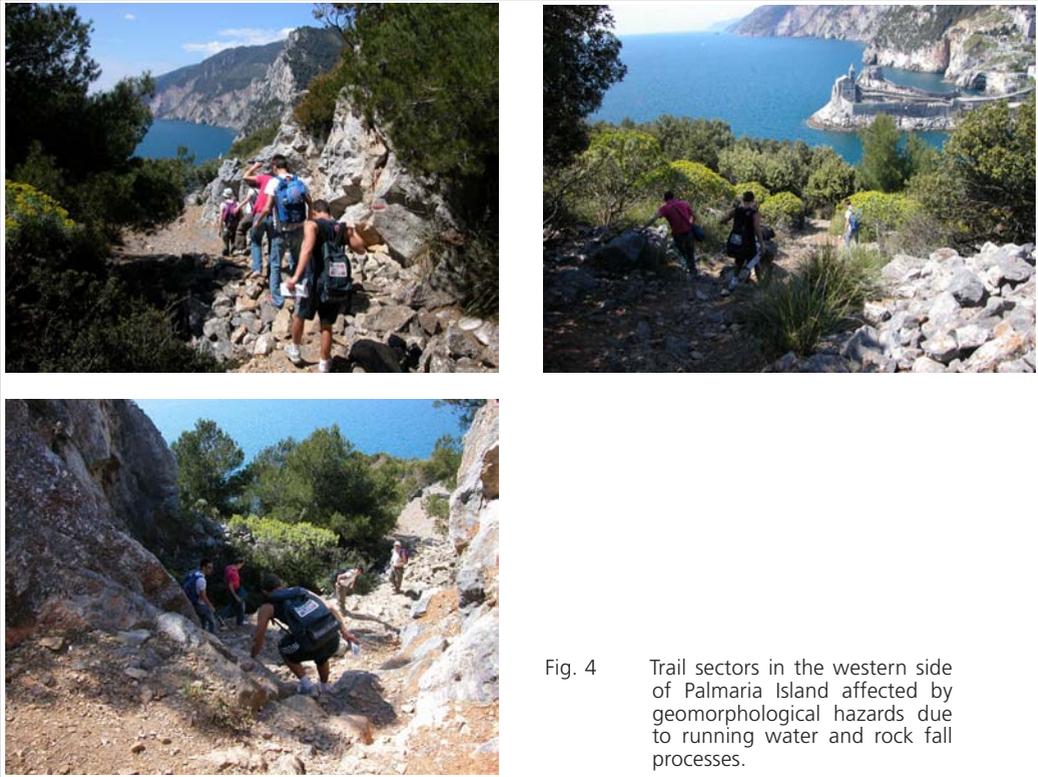
Fig. 4 Trail sectors in the western side of Palmaria Island affected by geomorphological hazards due to running water and rock fall processes.

conservation of the trails is, in general, quite good, with the exception of the steeper sectors, where the trail bed is affected by erosional phenomena due to running water. In the case of sudden and heavy rainfall, the path can become uneven and very slippery, and can be affected also by debris flows (Fig. 4).

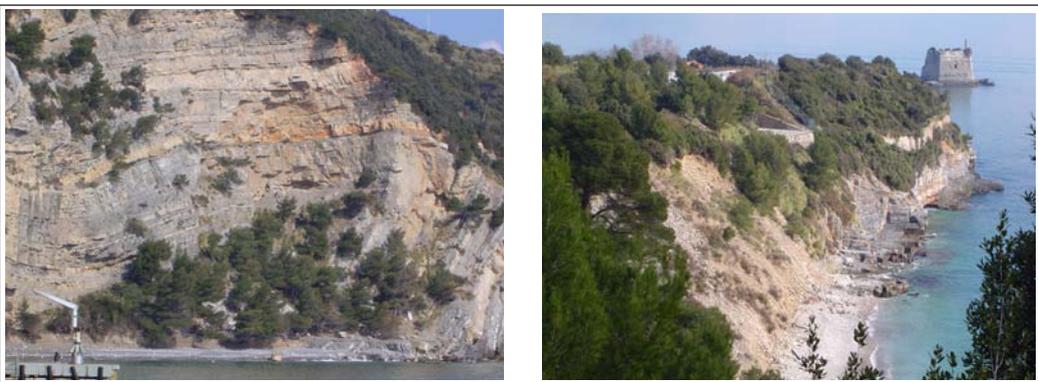
Fig. 5 Eastern sector of Palmaria Island. Cala del Pozzale (a) and Cala dello Schenello (b) beaches, affected by rock fall and debris slide phenomena.

Several rock fall phenomena have been detected along some parts of the trail network. Among these, we note potential rock falls, especially near the vertical fronts of the numerous abandoned quarries and the beaches frequented for sun tanning and bathing. Along the littoral, hazards are connected to strong sea storms, particularly those from the SW and SE (Fig. 5).

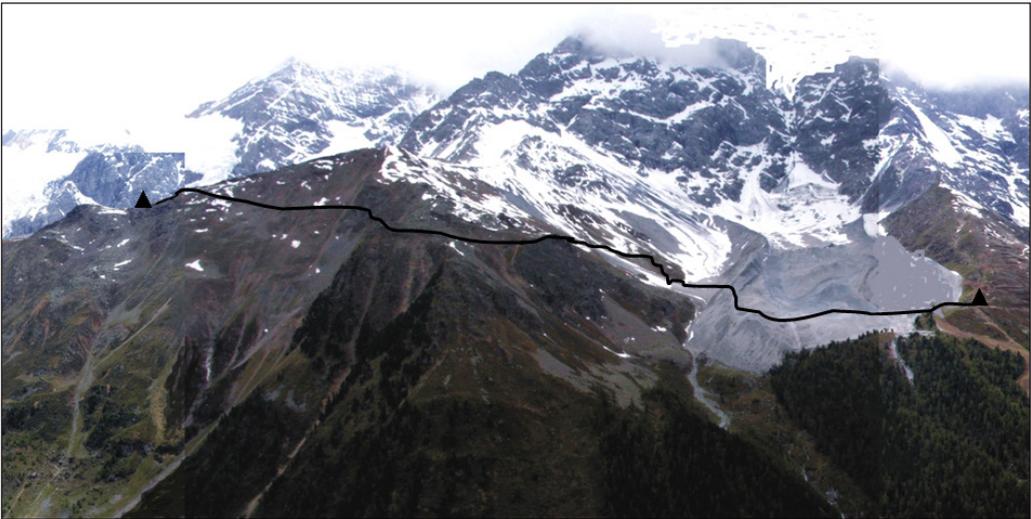
Fig. 6 Panoramic view of the western side of the Solda valley. Coston and K2 huts are indicated by triangles drawn on the limit of the trail. The trail is characterised by hazard sites and/or sites where vulnerability could increase because of local morphology or temporary situations (residual snow). Some of these situations are shown in figures 7, 8 and 9.

A portion of the trail connecting the Coston and K2 huts is analysed here (Fig. 6). Many of the situations correspond not only to geomorphological hazards but also to morphological situations inducing an increase of the tourist vulnerability, (Fig. 7-9).

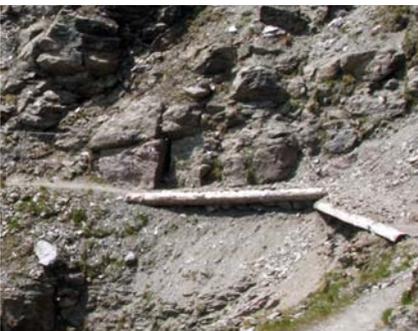
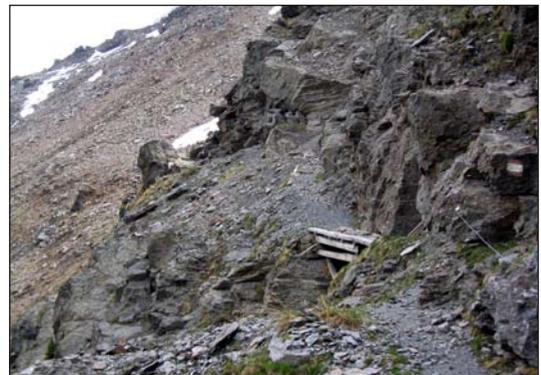
Fig. 7 A portion of the trail Coston-K2. Here the trail is cut into a steep rocky slope. The trail bottom can maintain its track thanks to a wooden support. Only one person at time can walk on it, with a steel rope for assistance. The symbol evidences the flat bottom of the trail and the material that characterises the trail (rectangular form), the slope inclination, the passage of only one person at time; the small circle indicates the presence of the safety support (steel rope).

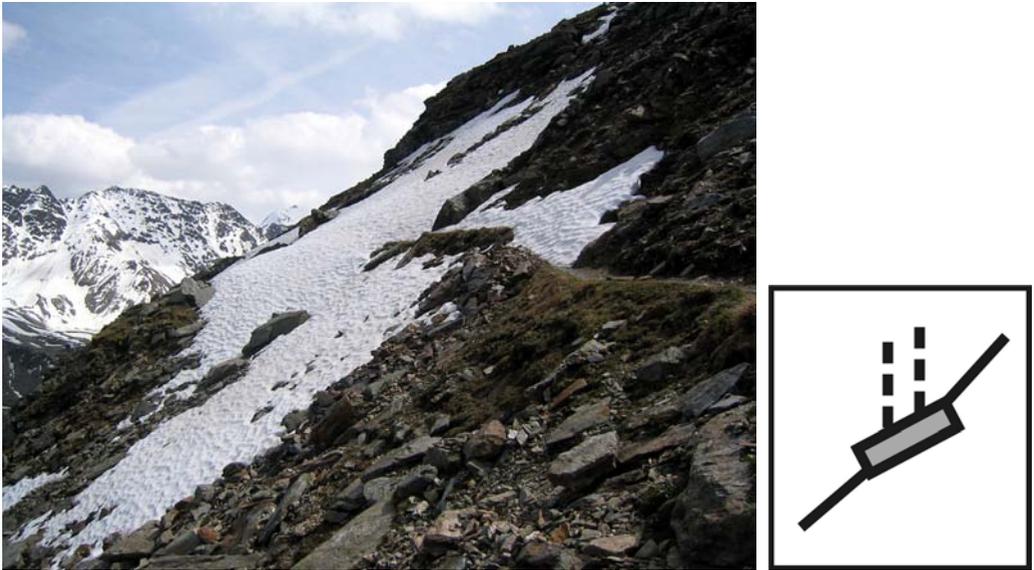
Fig. 8 A portion of the trail Coston-K2. The trail is hidden by residual snow. The picture was taken in June 2005. Snow patches are very frequent at the beginning of the summer season above 2500 m a.s.l. The symbol shows a grey rectangle corresponding to the snow cover; the inclination of the rectangle indicates the trail bottom height on the slope; the two segments, above and below the trail, represent approximately the inclination of the slope. The two dotted lines evidence the possibility of the passage of two people at time.

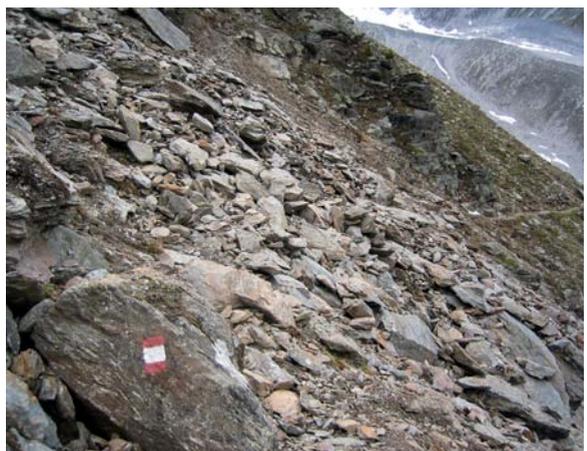
Fig. 9 Another portion of the same trail (represented in Fig. 6) partially buried under a deposit of debris and blocks. This is an example of a typical situation occurring at high altitudes at the beginning of the summer season. Due to the frequency of these instability phenomena, annual maintenance is required and, sometimes, new works after heavy rainstorms. This kind of hazard, if evidenced on geotourist maps, allows walkers to frequent trails with more safety. Moreover, public managers can use the same information to decide on modifications of the itinerary, temporary interruptions or in taking other decisions.
